SUMMER 2006

# CODAR CURRENTS

-- A solution for high VSWR on some 12MHz SeaSondes --

### Care and Feeding of Your Loopstick Antenna Receive Box

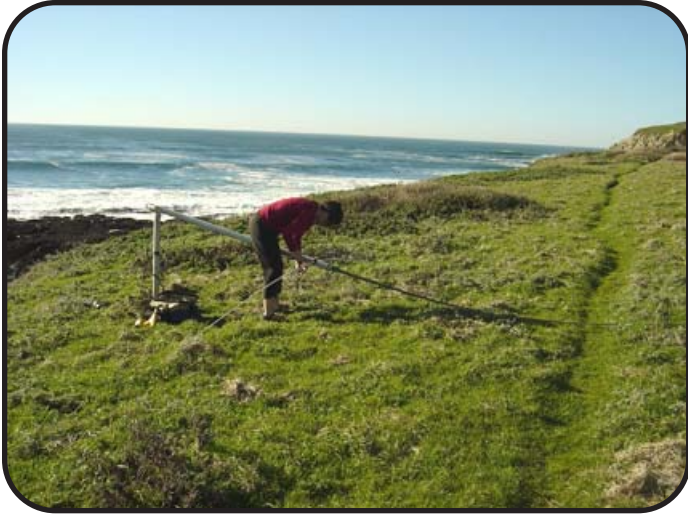
- 1) Disassemble transmit antenna to access the transmit feed (antenna head),

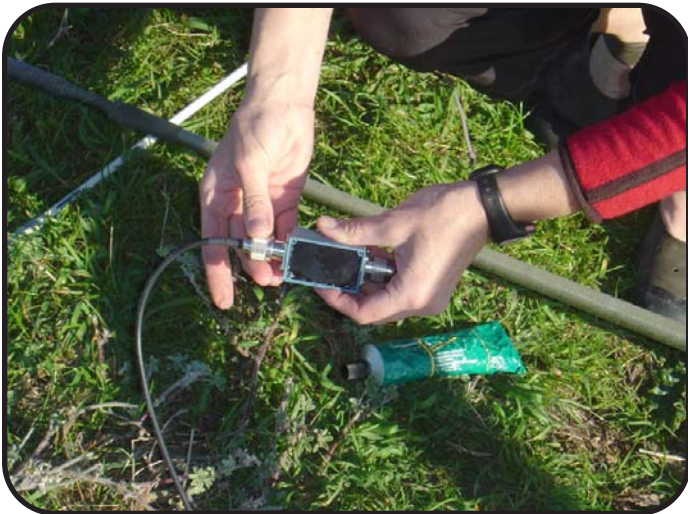
- 2) Thread the RG-58 cable segment through the mast and attach the potted air coil,

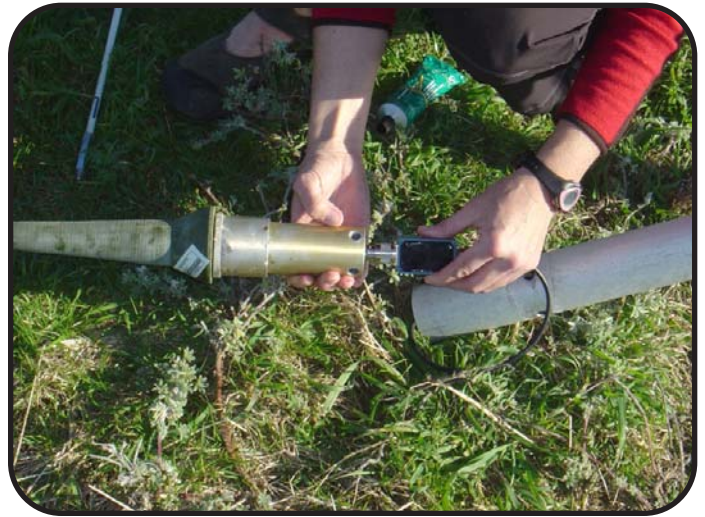
- 3) Attach the other end of the air coil to the antenna's transmit feed (antenna head),

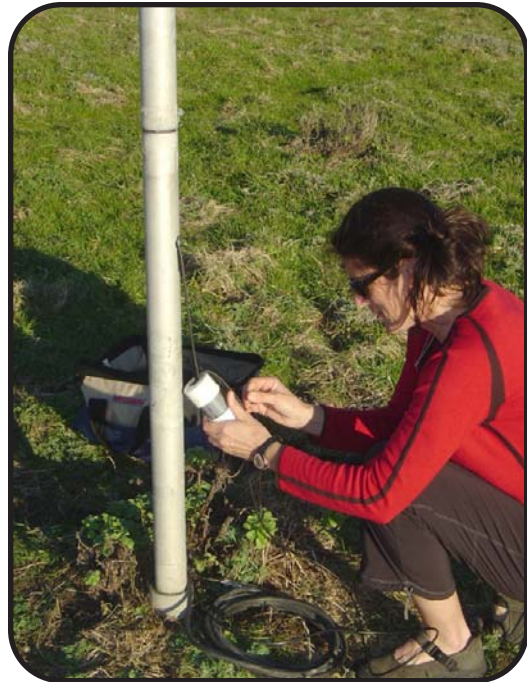
- 4) Adjust the position of the ferrite stack on the cable to fine tune (minimize) your VSWR reading.

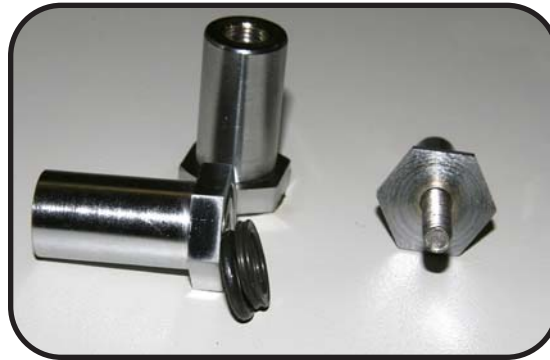
The most common cause of loopstick antenna failure is leakage of water through the lid gasket or o-ring seal on the monopole antenna connection on the lid. High winds can work the monopole fitting loose over time but operator error is the cause of leaks in the majority of cases.

Grooved O-ring with monopole fitting (Note the groove in the new style o-ring)

Note: we have recently switched to a "grooved" O-ring for the monopole fitting which has better sealing properties and is somewhat resistant to degradation by silicone grease. If you are planning to visit and service an older loopstick antenna and would like to replace the o-ring with the new style, please contact us at [support@codar.com](mailto:support@codar.com).

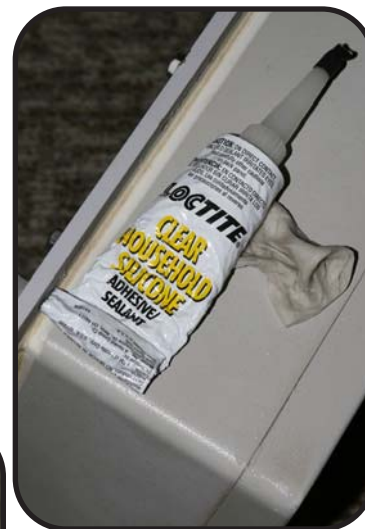
Use household silicone caulk to seal the gap

When re-installing the lid after an inspection, tighten the four corner screws a little bit at a time as you would when tightening the lug nuts on your wheel after a tire change. Then inspect the gap clearance around the perimeter of the lid to be sure it has been tightened evenly. As an added measure of protection, you can apply a small bead of silicone bathtub caulk to the gap. Use just enough to seal the crack and then use a damp finger tip or damp paper towel to wipe off the excess before it dries. You don't want to force the caulk into the gasket seal but just seal the crack.

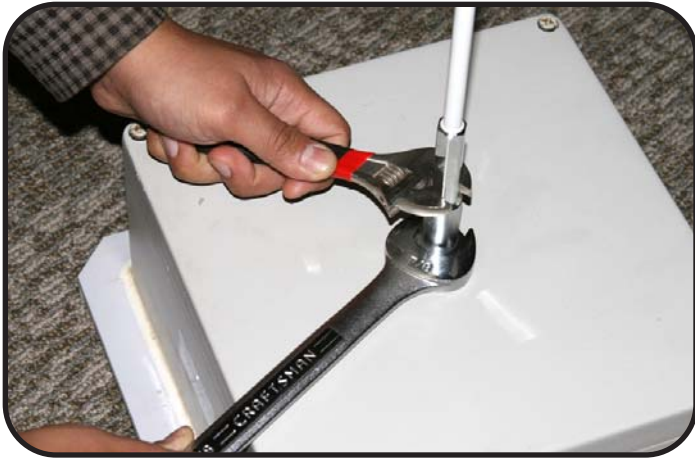
Remove Monopole Whip  
(Use a second wrench with opposing force to prevent monopole fitting from unscrewing)

Always use a second wrench when applying torque to unscrew the whip from the monopole fitting on the receive box lid. If this fitting is accidentally loosened it will also need to be tightened using two wrenches. The box lid will need to be removed in order to do this. Check the condition of the o-ring and that the fitting is tight whenever you have the opportunity (at least once a year).

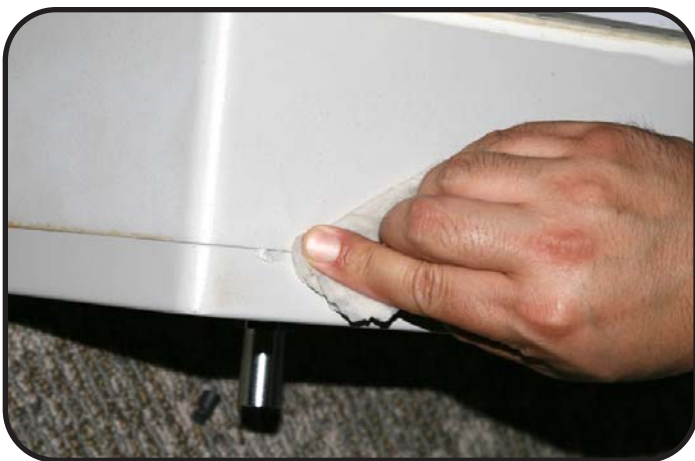
Wipe off the excess caulk

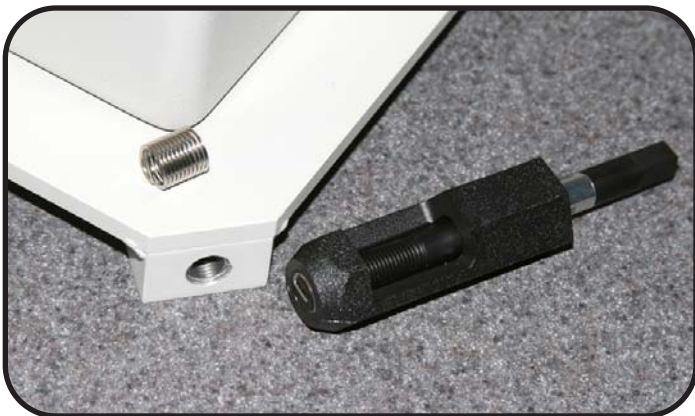
Damage to the Helicoil® can occur when the ground plane whips are cross-threaded into the Helicoil® or the leading edge of the Helicoil® is pulled out of the tapped hole. If this occurs, the damaged Helicoil® can be removed with a small pair of needle-nose pliers and the hole can be cleaned out with a 25/64" tap. A new Helicoil® can then be inserted IF you have the "special tool". The tool can be purchased for about \$40 ([www.toolsources.com](http://www.toolsources.com), part #HEL5528-6) and is highly recommended as an addition to your field toolkit.

Helicoil Thread Insert and Tool

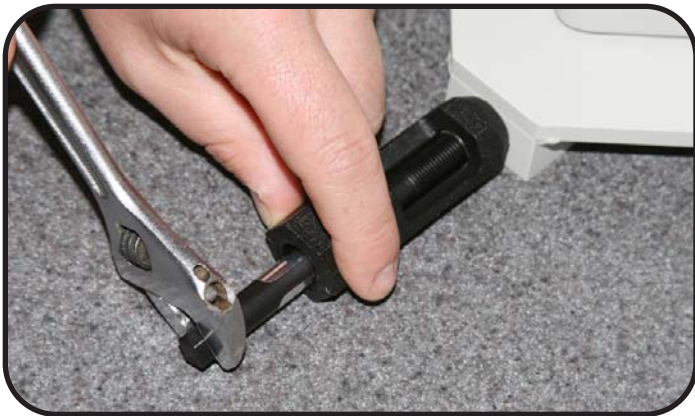
Inserting Helicoil
